Belvac Production Machinery Technical Bulletin

ISSUE 1, VOLUME 17, APRIL 2014

590 / 595 / 810 FLANGER ANTI-ROTATION BRACKET UPGRADE

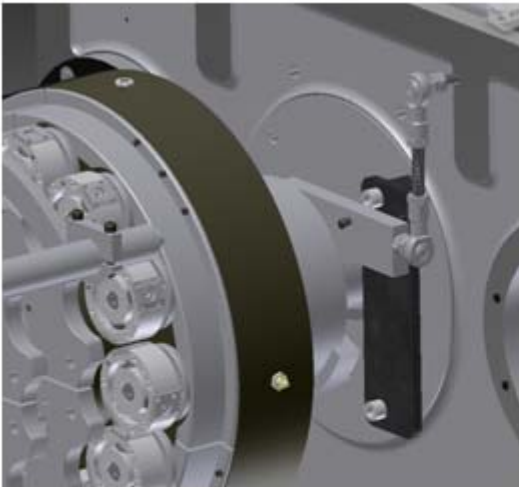
Original Turn Buckle Design

Belvac has received feedback from various customer can plants the anti-rotation turn buckle design has failed at the rod end bearing when removing flanger tooling. The setup of the turn buckle is sensitive, in that the threaded rod must be vertical to take optimum advantage of static reactions. In addition, the flanger tool bolt tightens beyond the initial mounting torque, causing greater load on the rod end bearings during disassembly from the machine.
