Information for Customers Operating & Maintaining Belvac Machines

ISSUE 4, VOLUME 17, OCTOBER 2014

THE BELVAC (TBN) MANUAL SCHEDULE LUBRICATION UPDATE

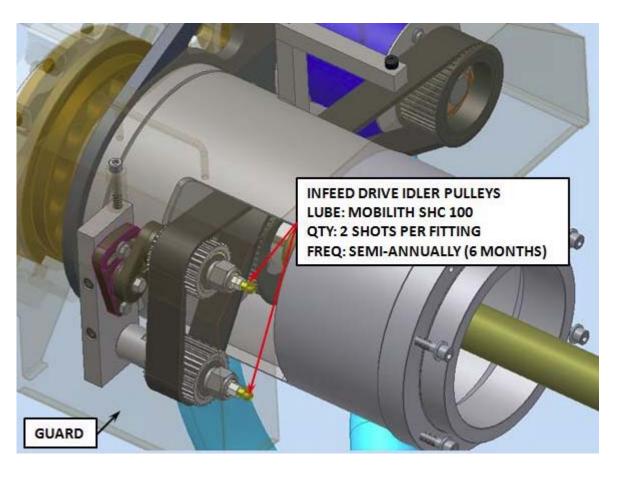
The Belvac Necker (TBN) Infeed Belt Drive has two idler pulleys which must be regularly lubricated as part of your preventive maintenance program. Access to these pulleys requires removal of the guard over the infeed drive as shown in the following:

Note: Using a hand grease gun, one shot of grease = 0.10 in^3 (1.6 cm³).

A remote lubrication kit, **P/N 8953176** is available for easier access in lubing these idlers without removal of the guard over the drive.
